REPORT TO MUNICIPAL PLANNING TRIBUNAL

WARD 65: APPLICATION FOR ADMINISTRATIVE PENALTY IN TERMS OF THE CITY OF CAPE TOWN MUNICIPAL PLANNING BY-LAW, 2015 (MPBL) IN RESPECT OF ERF 10775, GRASSY PARK, 8 BEATRICE CLOSE, LOTUS RIVER

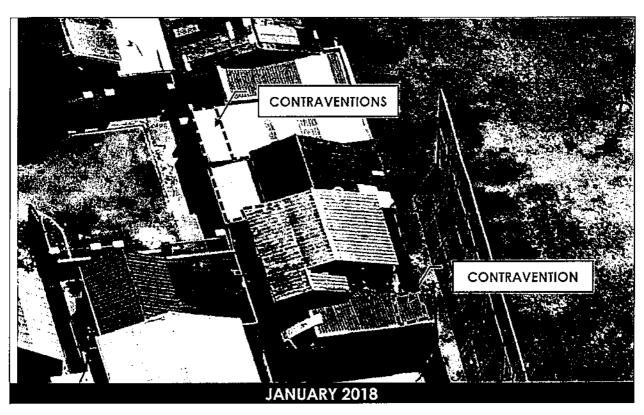
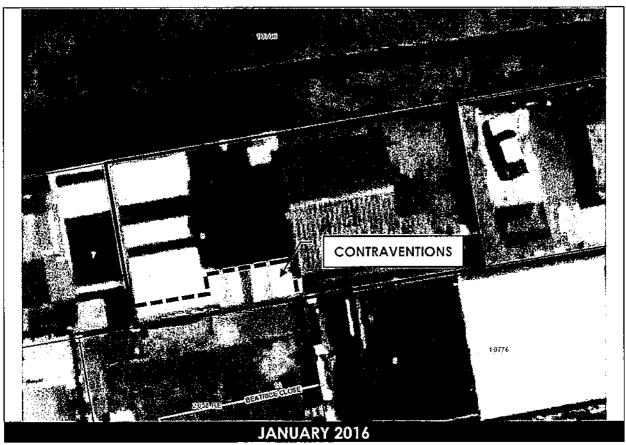
127
ANNEXURE D: AERIAL PHOTOGRAPHS

Duration: According to the Land Use Management application form, the duration of the contravention is 4 years. The City's aerial photographs show that the unauthorised veranda has existed since November 2009, whereas the unauthorised carport has existed since the year 2016.
