## **CITY OF CAPE TOWN INLAND WATER QUALITY REPORT FOR THE PERIOD APRIL 2020 TO MARCH 2022 (2020 AND 2021 REPORTING PERIODS)**

**FINAL**

MAY 2023

### **TECHNICAL REPORT**

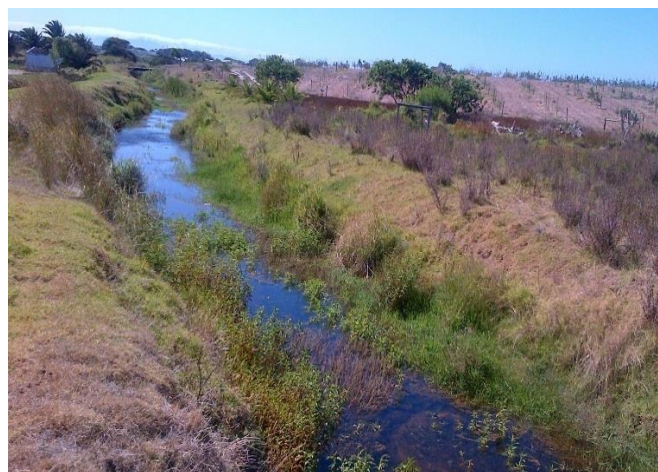
**Valley-bottom wetland / 'wetland transitional' stream**  
**Channelised and partially diverted Keyesers River**

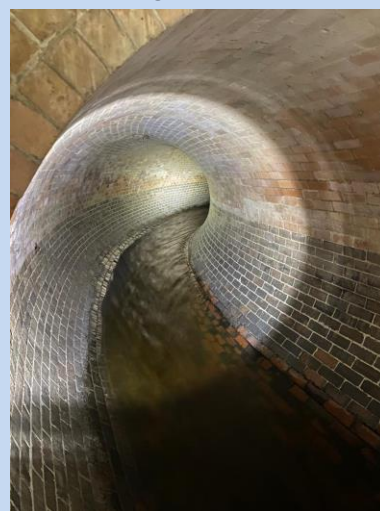
Photo 2.2: The Platteklouf River, which is passed under the City Bowl in covered, brick-lined culverts

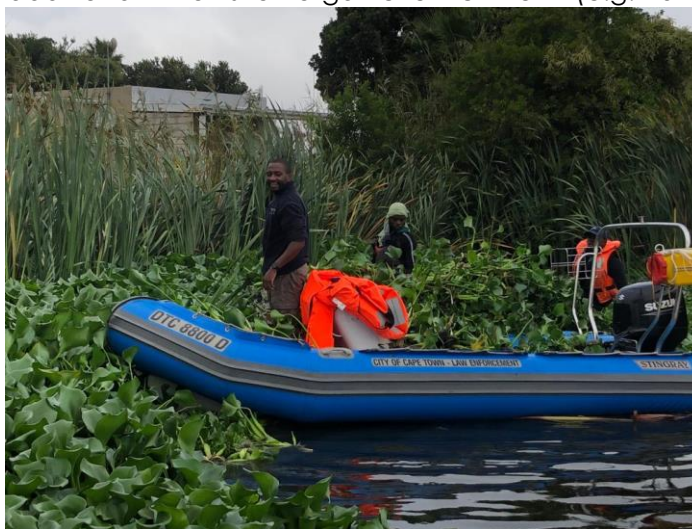
**Photo 5.1.1**  
The CCT's False Bay Nature Reserve officials remove  
invasive water hyacinth from Zeekoevlei

In the Western Cape, floating non-algal aquatic plants are all alien to this area, and likely to proliferate under conditions of elevated nutrients. The most problematic floating plant species include water hyacinth (*Pontaderia crassipes*), duck weed (*Lemna gibba*) and *Ceratophyllum demersum* (water hornwort). These can create serious management problems. Water hyacinth in particular blocks channels and open waterbodies, leading to flooding and affecting their suitability for recreational uses such as sailing, rowing, and kayaking.

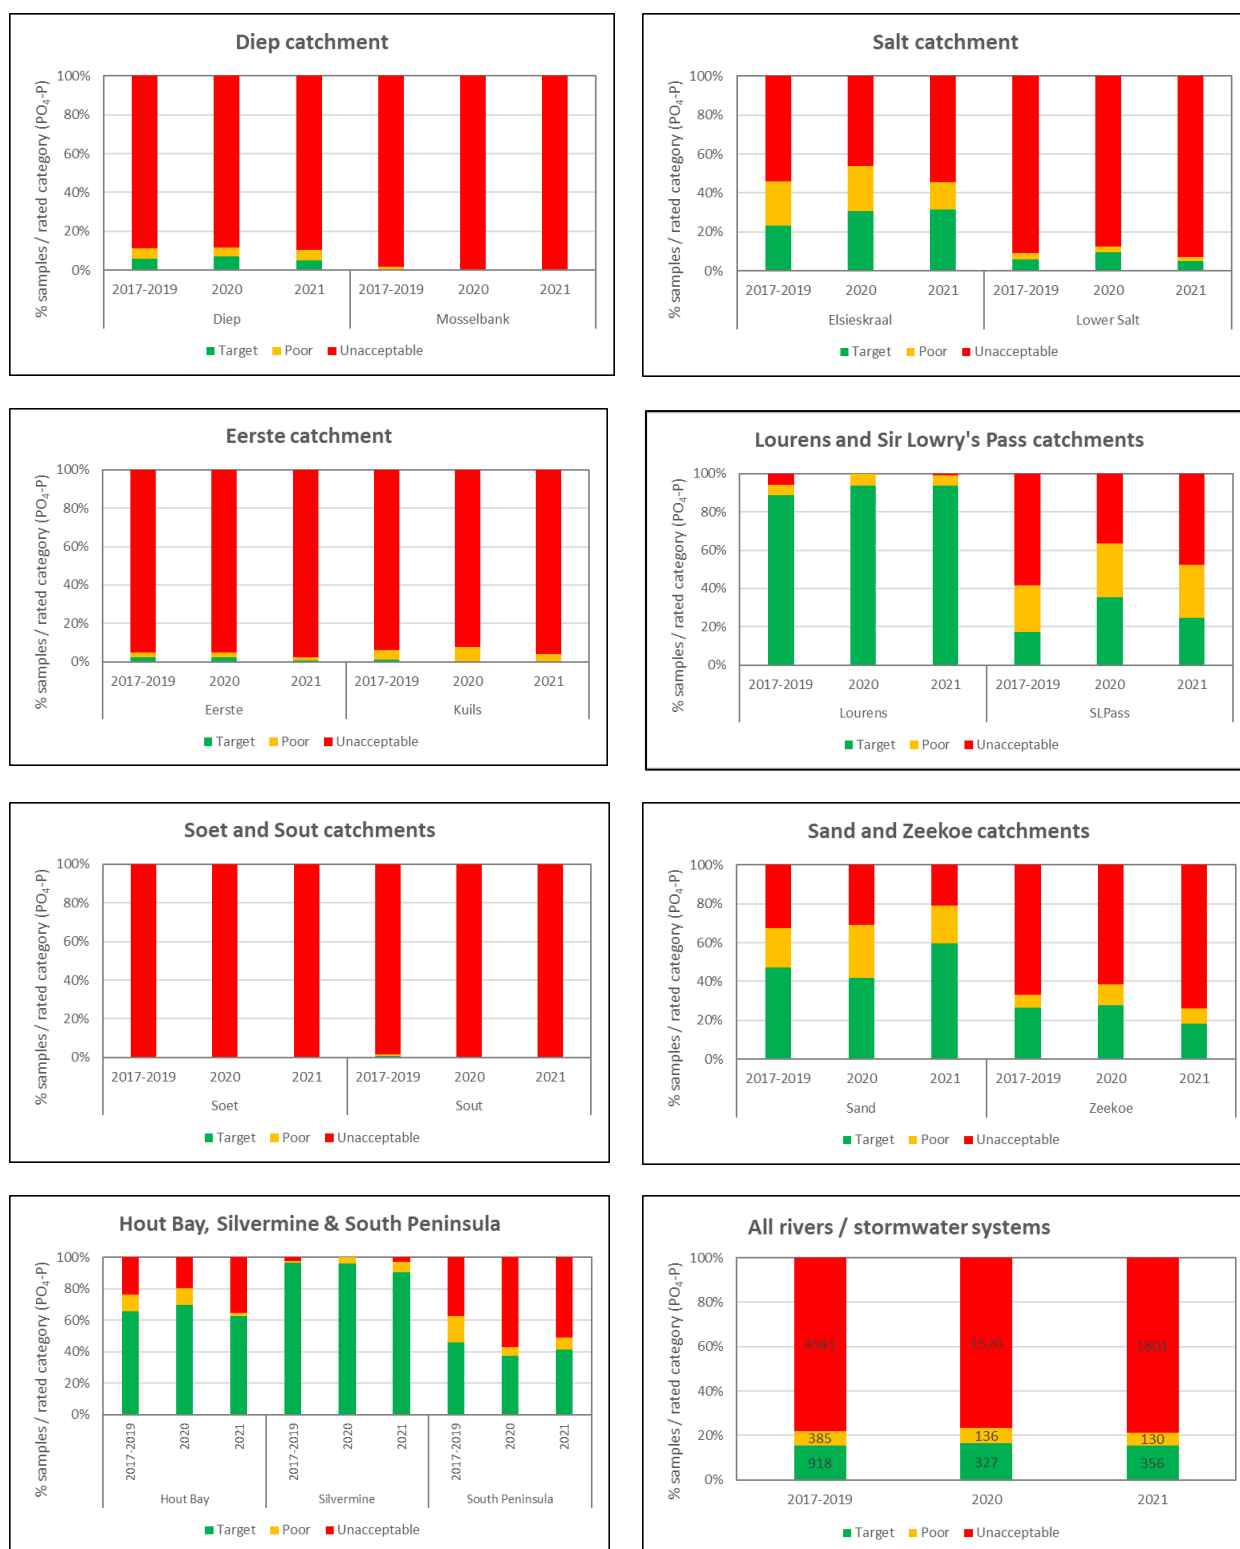
Figure 5.1.1

Percentage of phosphate (PO<sub>4</sub>-P) samples falling within each rated category for this variable, per subcatchment. Thresholds for rated categories as defined in Table 3.2. Data for river / 'flowing' water monitoring points in each subcatchment. Subcatchments as shown in Figure 2.1. Total number of samples considered shown in bars in bottom right plot ('All rivers / stormwater systems').

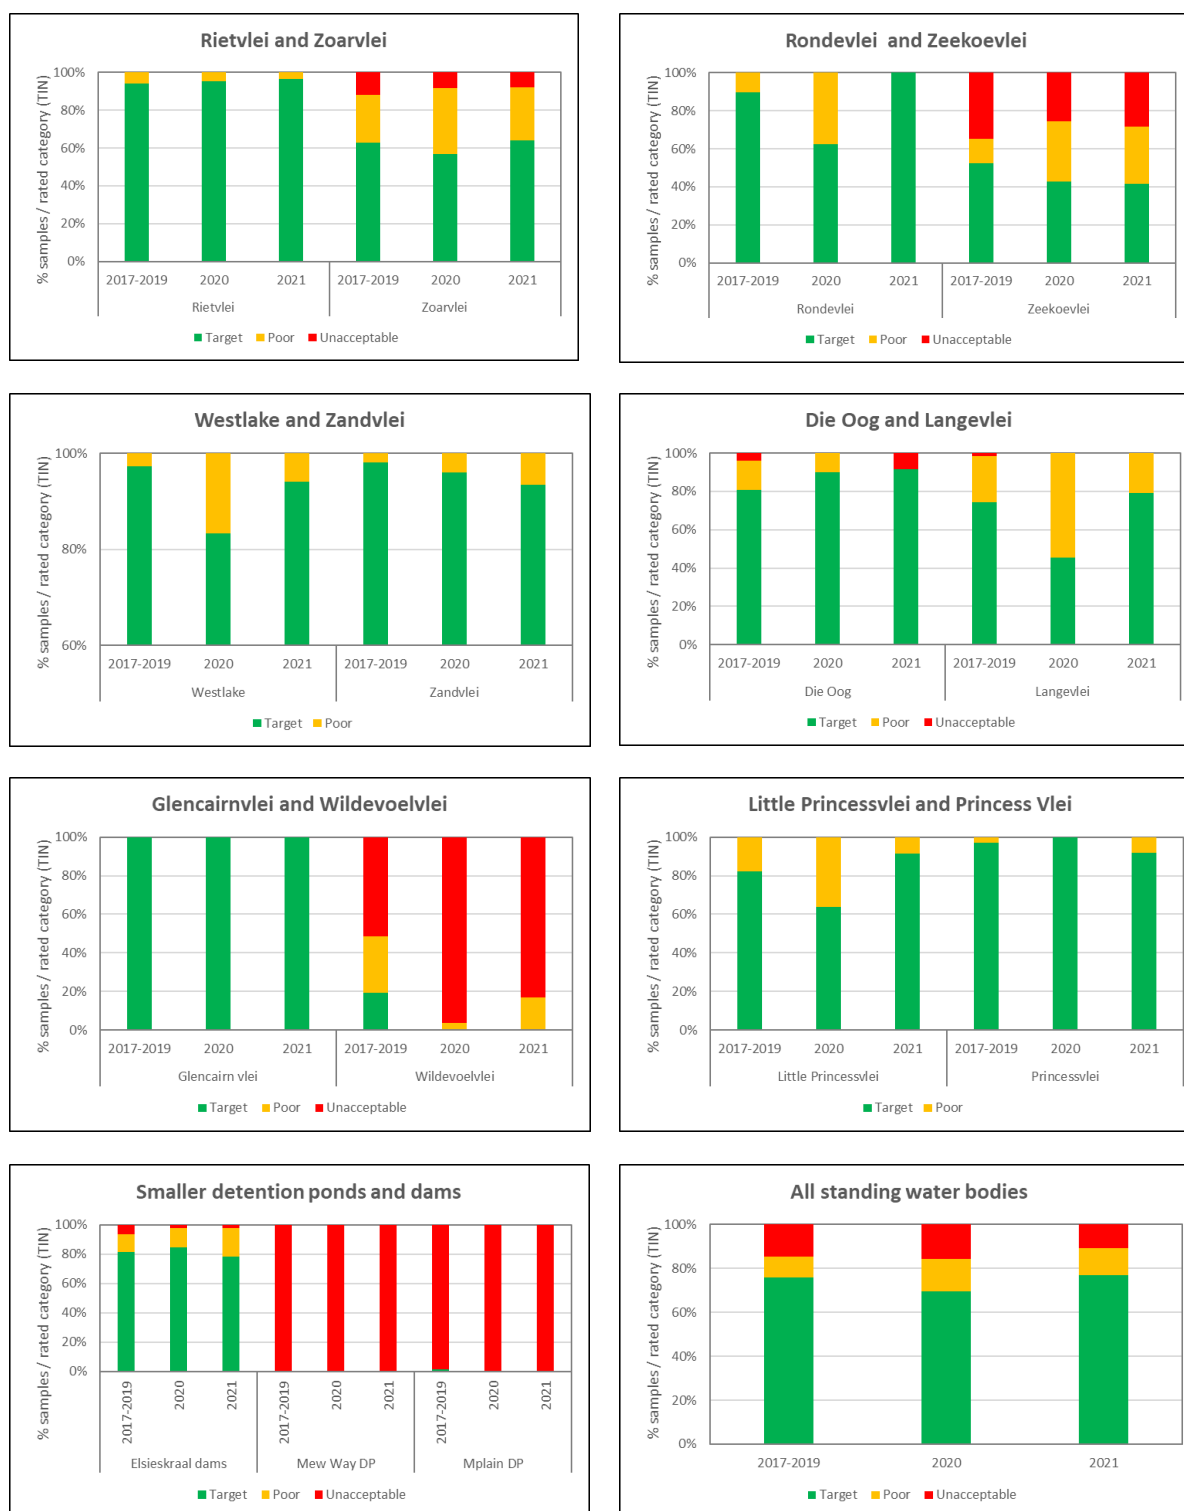
Figure 5.1.6

Percentage of Total Inorganic Nitrogen (TIN) samples falling within each rated category for this variable, per monitored standing water system. Thresholds for rated categories as defined in Table 3.3. Data for sample points in standing waterbodies / vleis and detention ponds. Total number of samples considered shown in bars in bottom right plot ('All standing waterbodies').

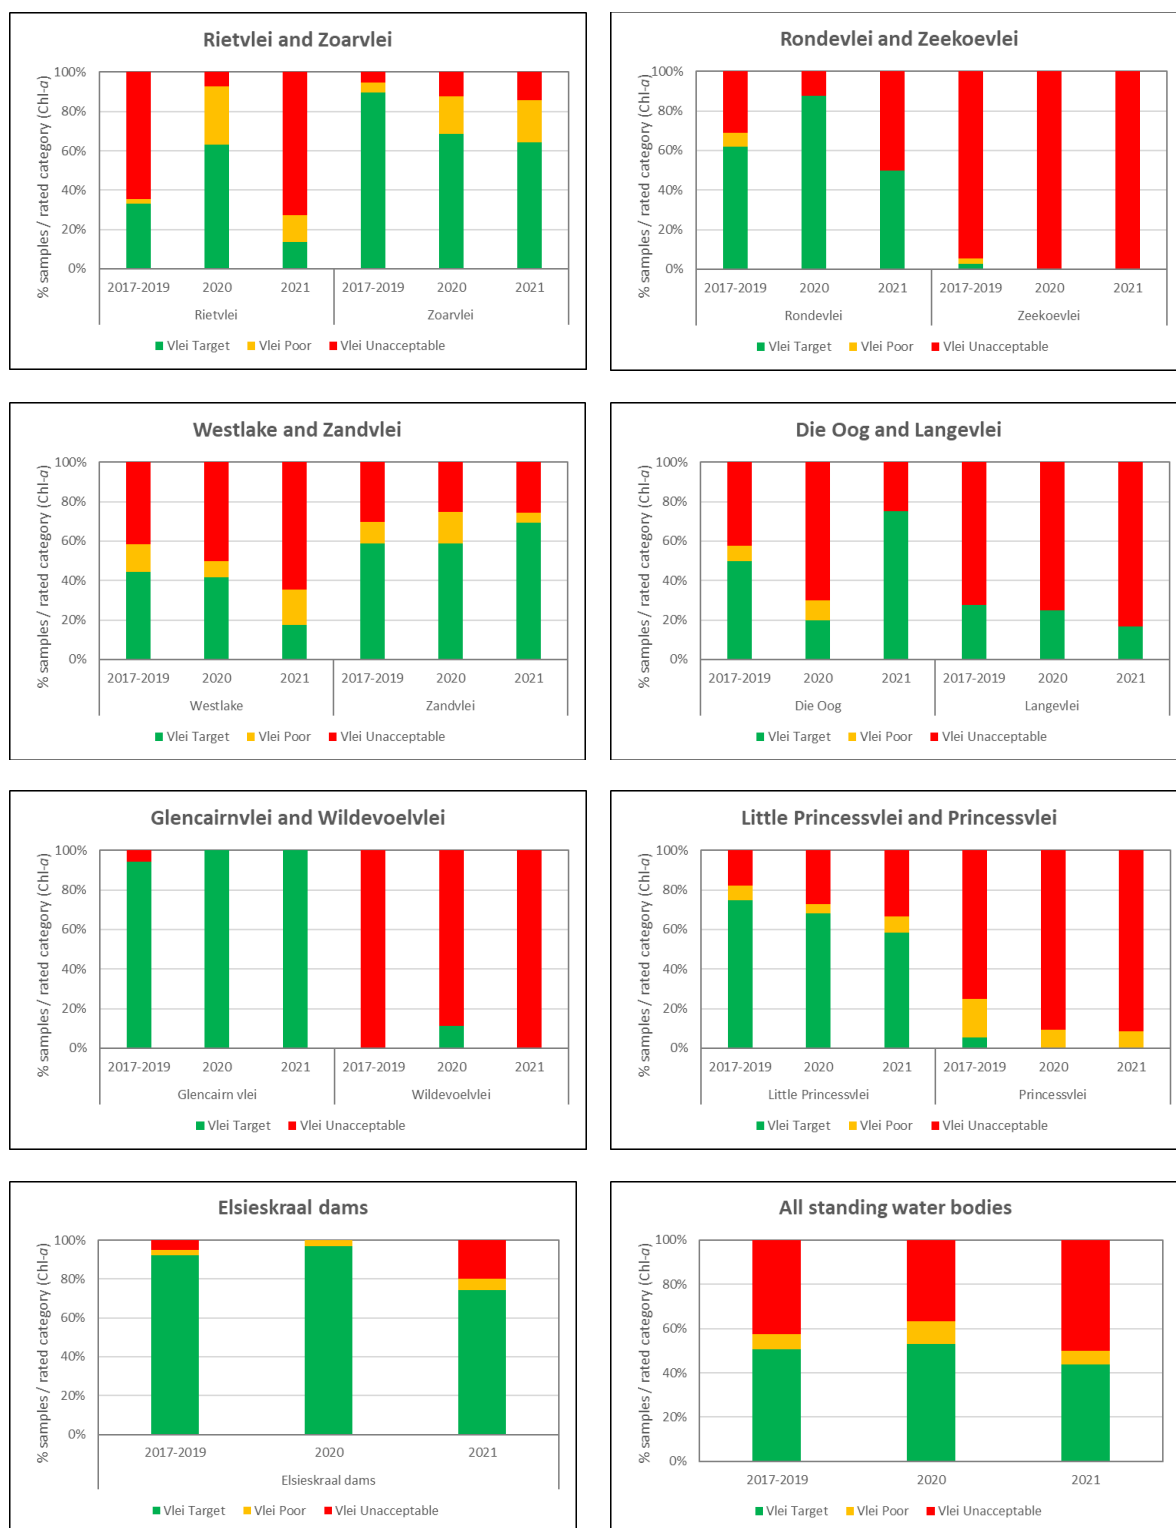
Figure 5.2.1

Percentage of chlorophyll-a (Chl-a) samples falling within each rated category for this variable, per monitored standing water system. Thresholds for rated categories as defined in Table 3.3. Data for sample points in standing waterbodies / vleis and detention ponds. Total number of samples considered shown in bars in bottom right plot ('All standing waterbodies').

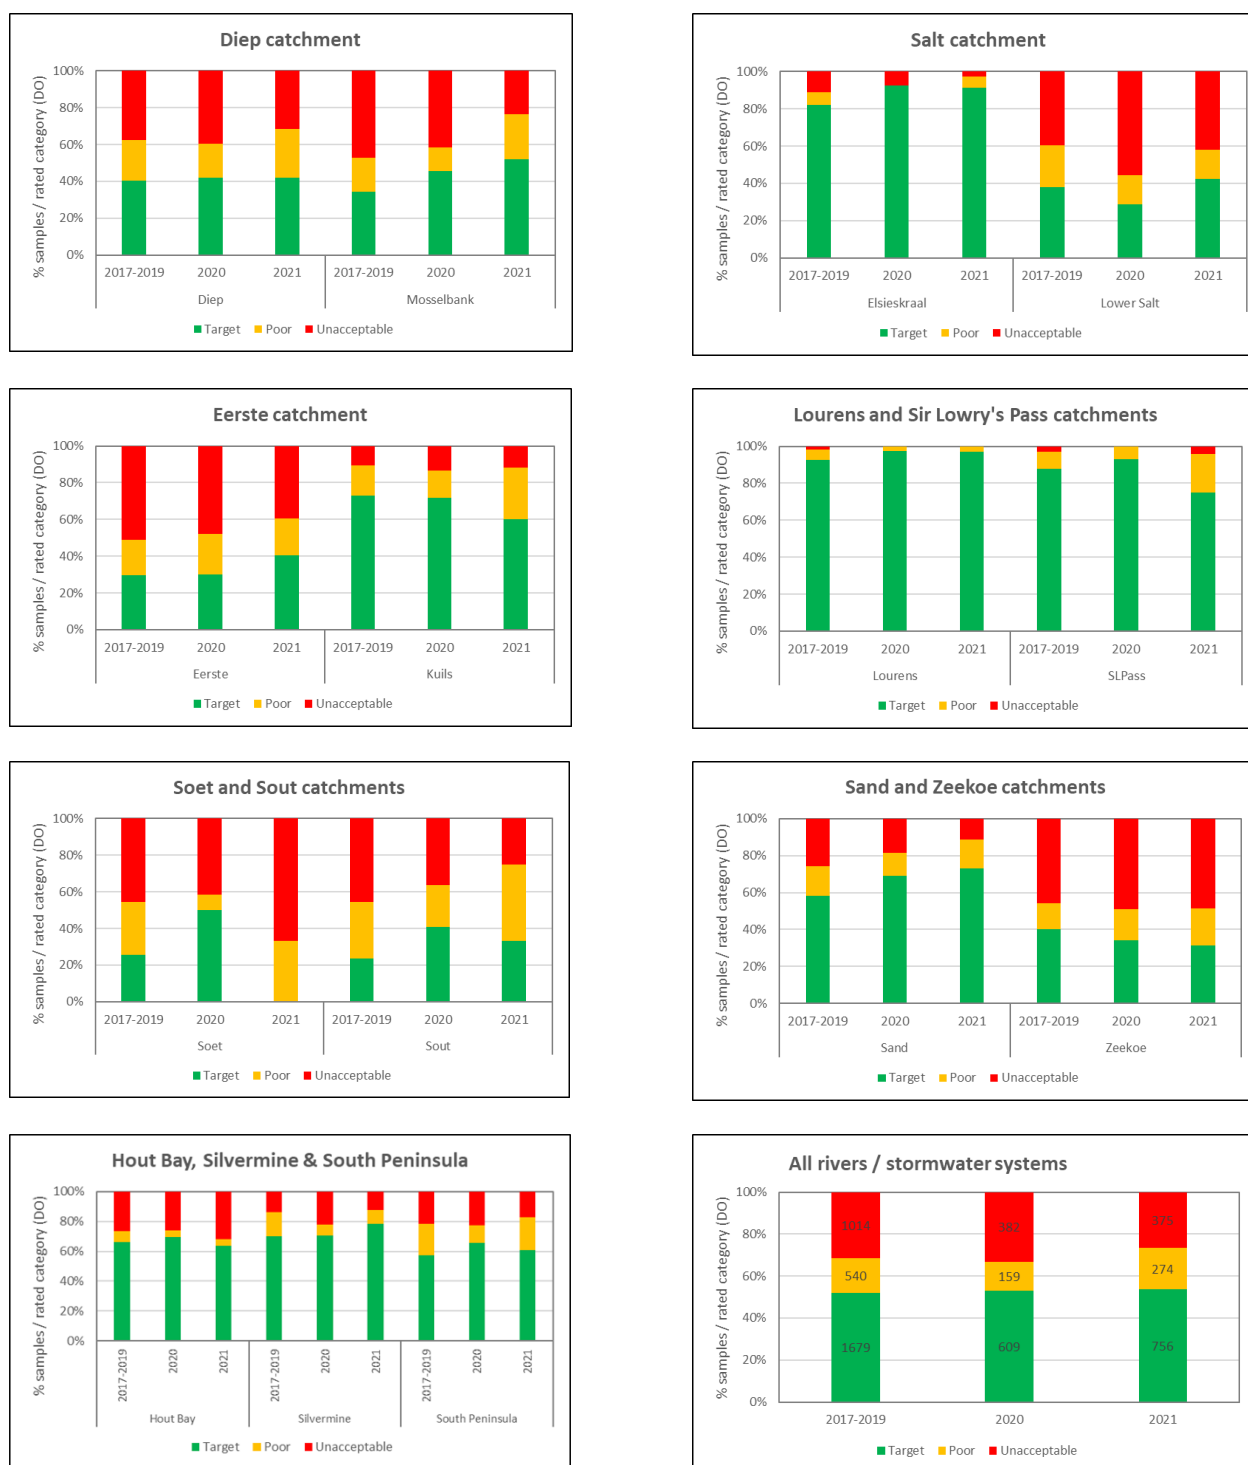
Figure 5.3.1

Percentage of Dissolved Oxygen (DO) falling within each rated category for this variable, per subcatchment. Thresholds for rated categories as defined in Table 3.2. Data for river / 'flowing' water monitoring points in each subcatchment. Subcatchments as shown in Figure 2.1. Total number of samples considered shown in bars in bottom right plot ('All rivers / stormwater systems').

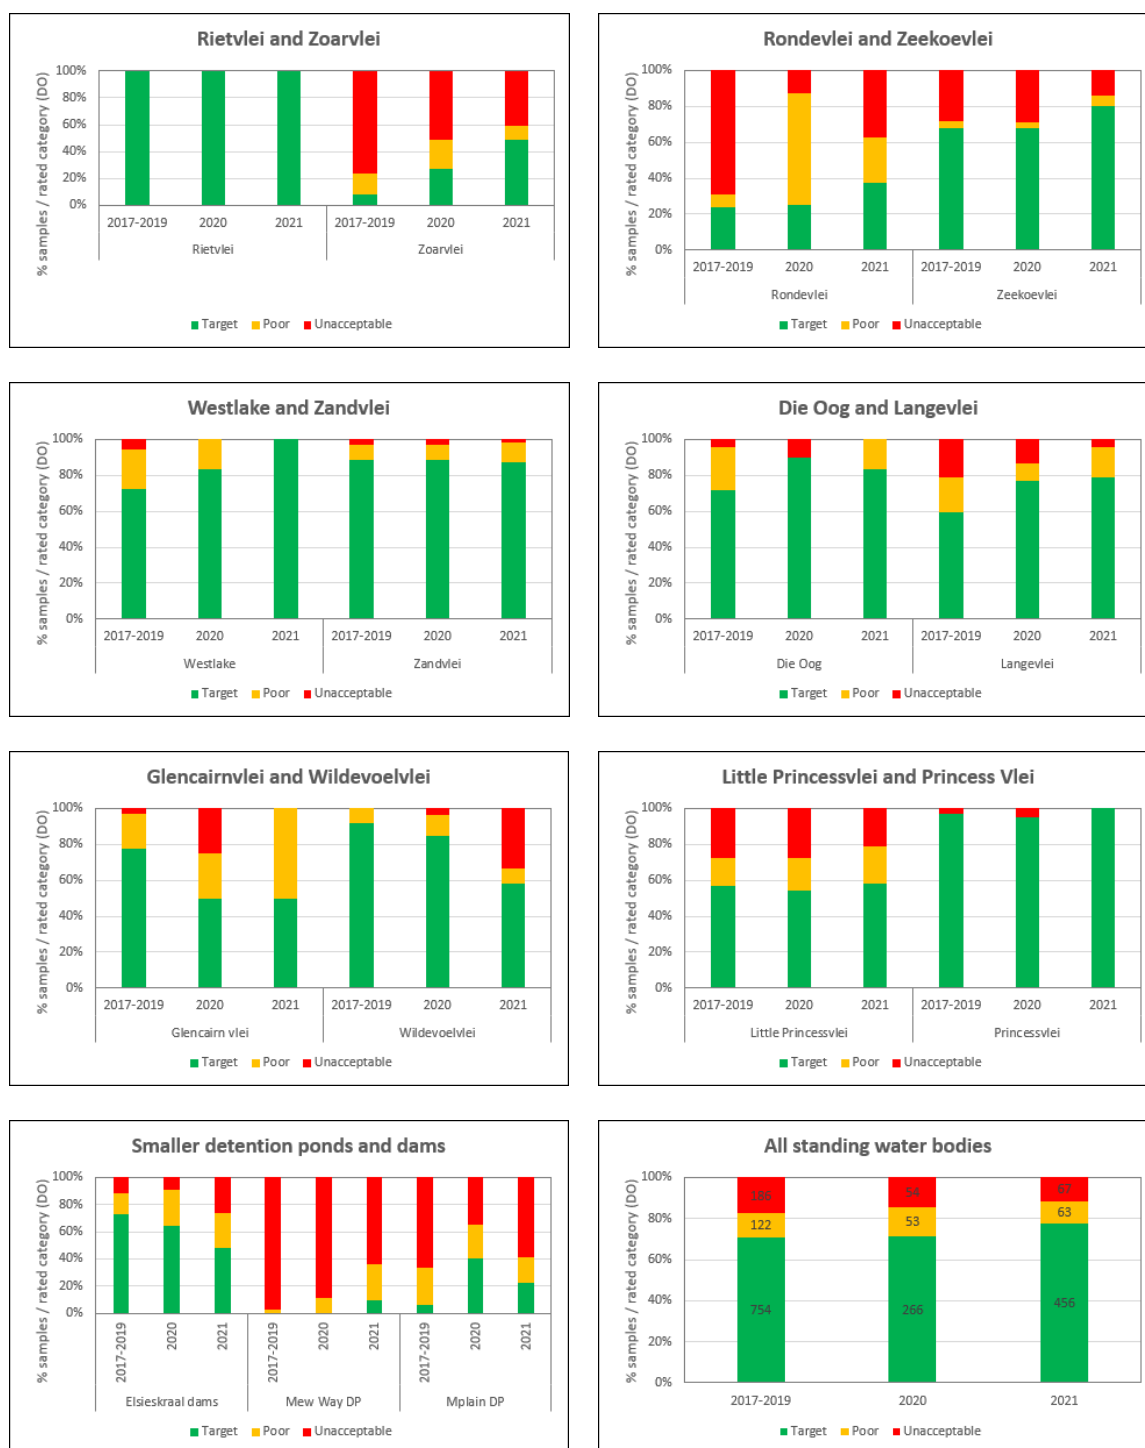
Figure 5.3.2

Percentage of Dissolved Oxygen (DO) samples falling within each rated category for this variable, per monitored standing water system. Thresholds for rated categories as defined in Table 3.3. Data for sample points in standing waterbodies / vleis and detention ponds. Total number of samples considered shown in bars in bottom right plot ('All standing waterbodies').

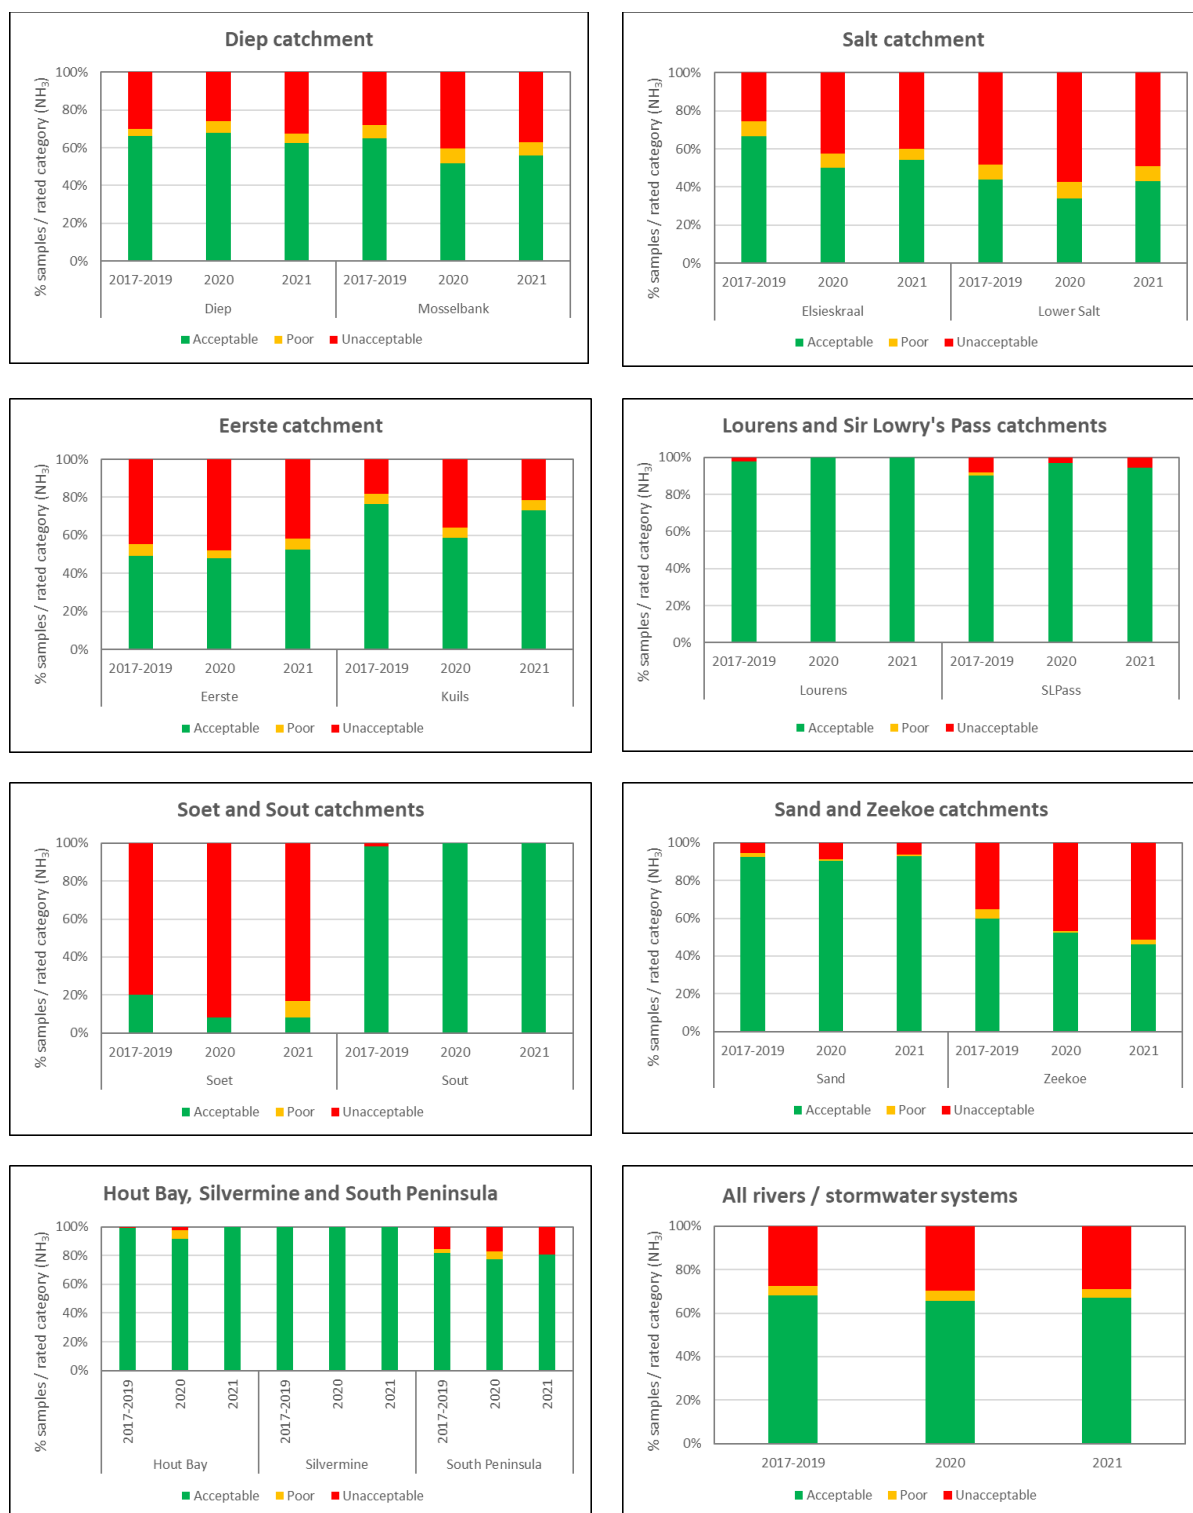
Figure 5.4.4

Percentage of un-ionised ammonia (NH<sub>3</sub>) samples falling within each rated category for this variable, per subcatchment. Thresholds for rated categories as defined in Table 3.2. Data for river / 'flowing' water monitoring points in each subcatchment. Subcatchments as shown in Figure 2.1.

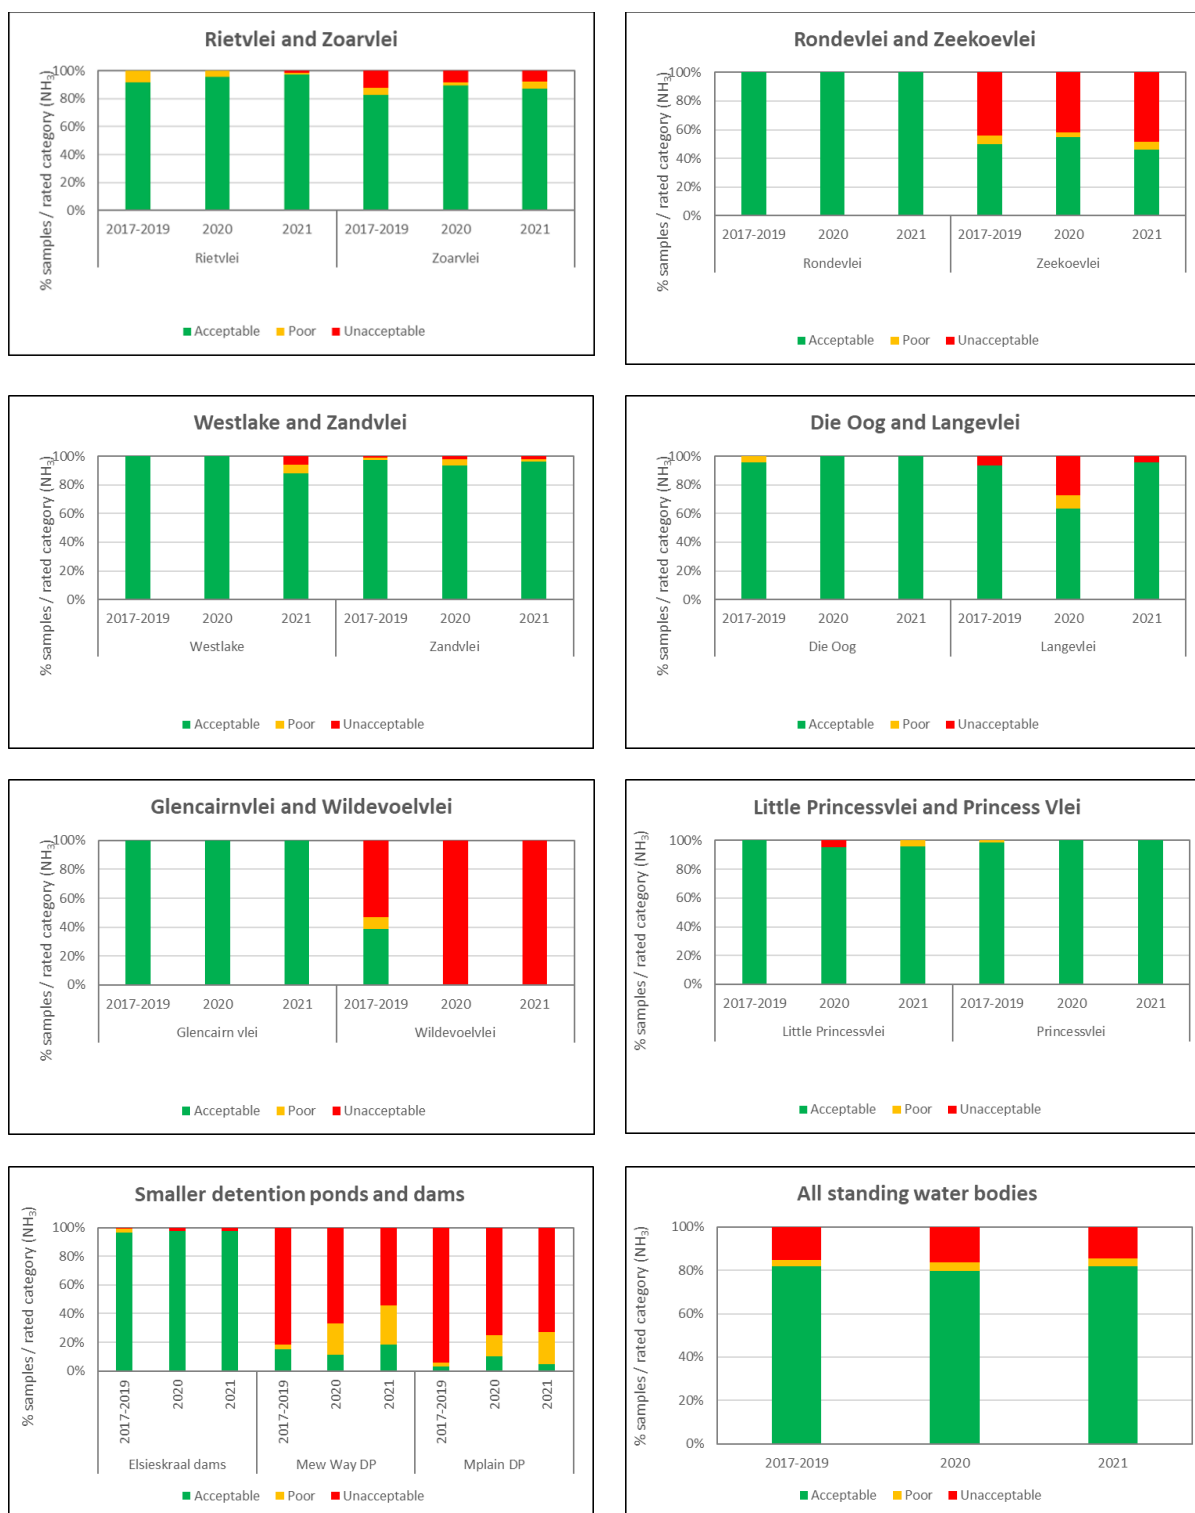
Figure 5.4.5

Percentage of un-ionised ammonia (NH<sub>3</sub>) samples falling within each rated category for this variable, per monitored standing water system. Thresholds for rated categories as defined in Table 3.3. Data for sample points in standing waterbodies / vleis and detention ponds.

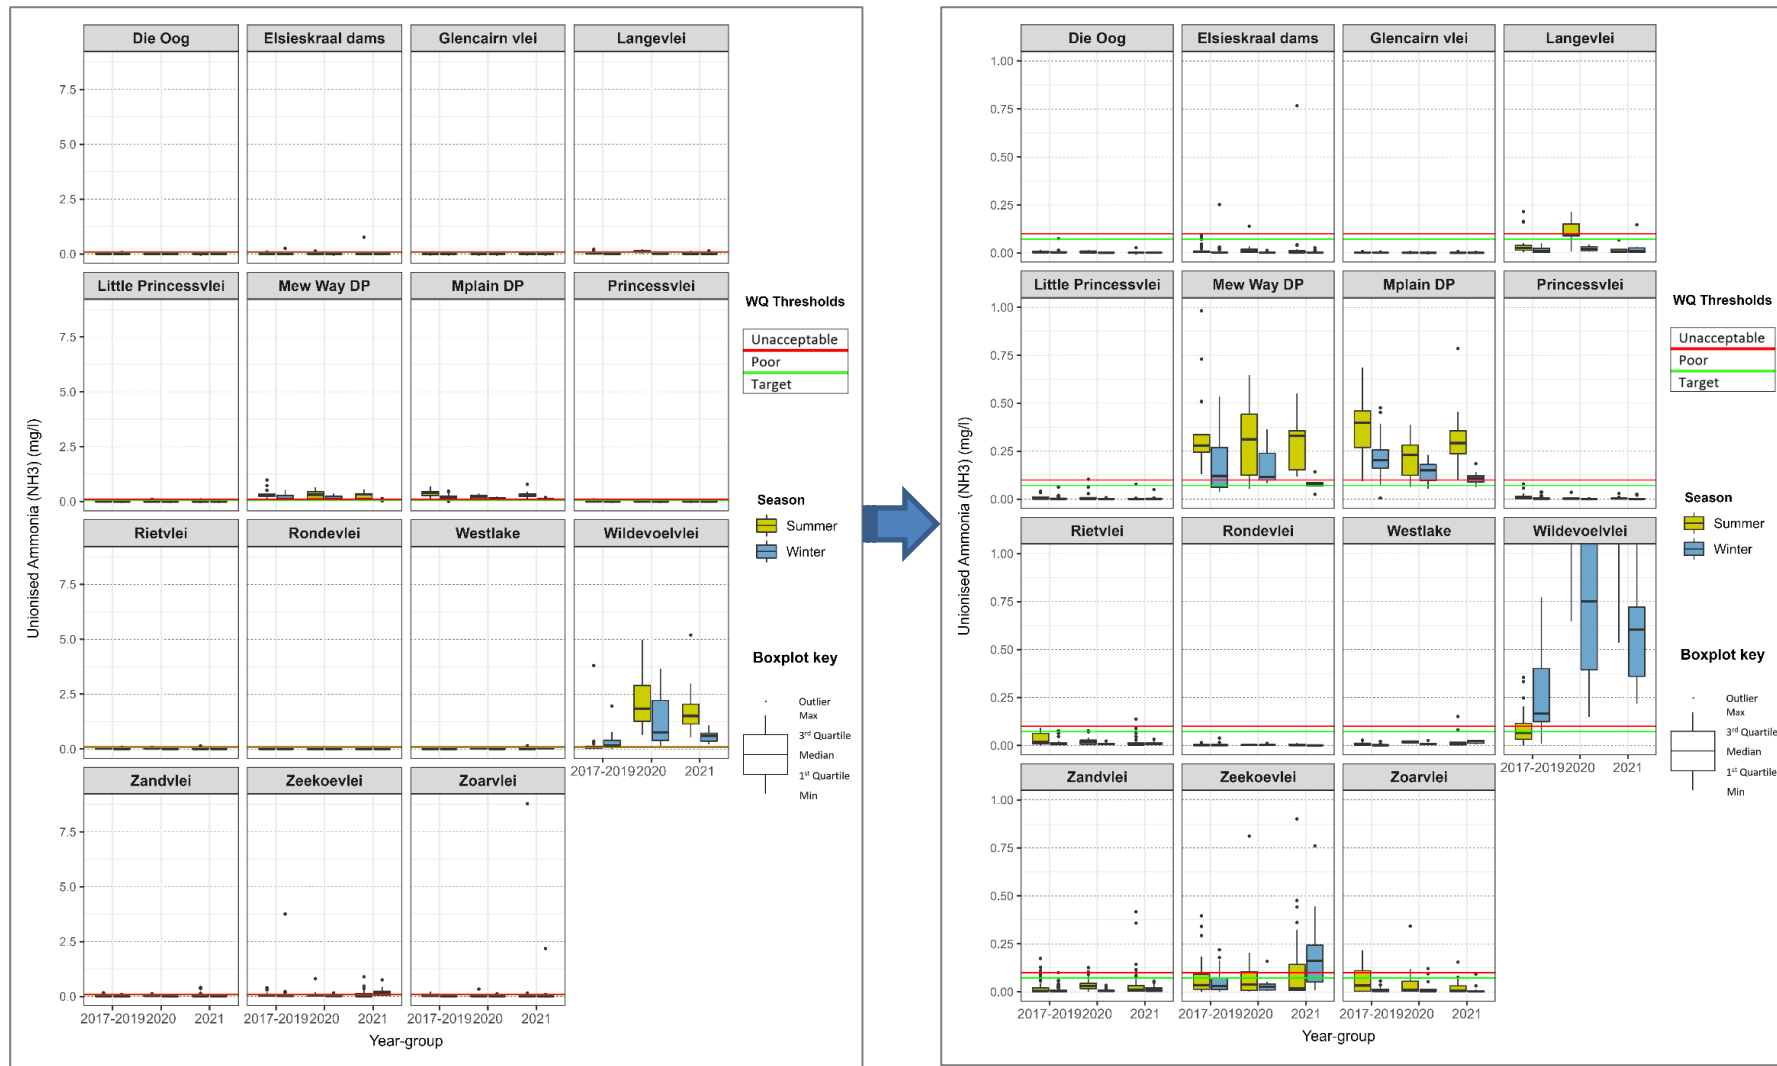
Figure 5.4.4

Comparison of un-ionised ammonia for standing water systems (vleis, dams and detention ponds) from the 2021 reporting period, with those from 2020 and the previous three years (2017 to 2019) combined. Data analysed as summer and winter datasets. Marked thresholds as per Table 3.3. Closer view (reduced y-axis) shown in right hand figure.

The seasonal boxplots for un-ionised ammonia in **Figure 5.4.3 and 5.4.4** (and the annual boxplots in **Appendix D**) provide the following additional insight in relation to the potential for ammonia toxicity:

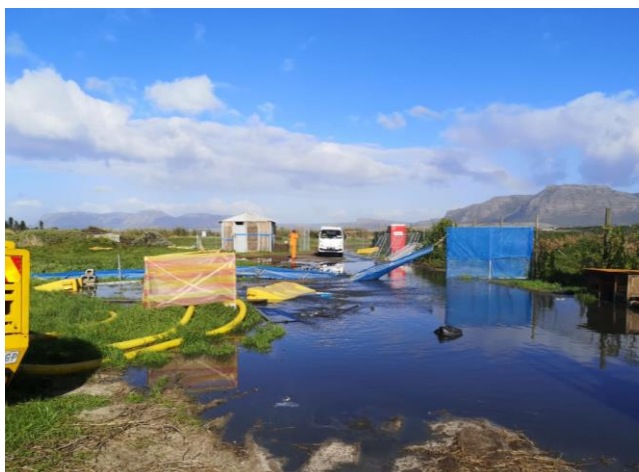
**Photo 5.5.1**  
Attending to a major sewage spill at the Cape Flats  
WWTW in July 2021, when raw effluent entered  
Zeekoevlei – a Ramsar wetland

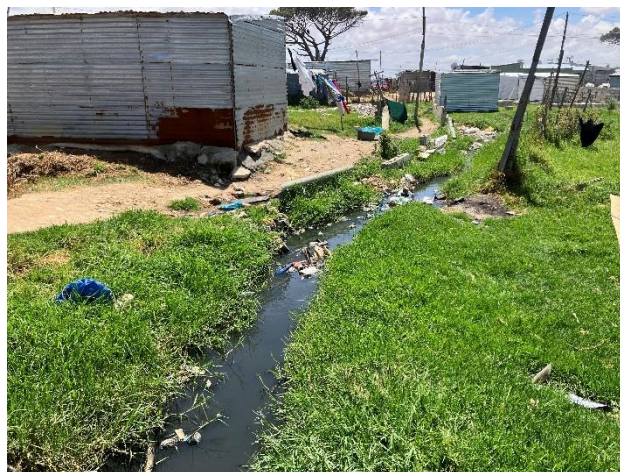
**Photo 5.5.2**  
Dry-season runoff of sewage-contaminated flows  
from the Kleine Stink River, through the Dunoon  
informal settlement (Diep subcatchment)

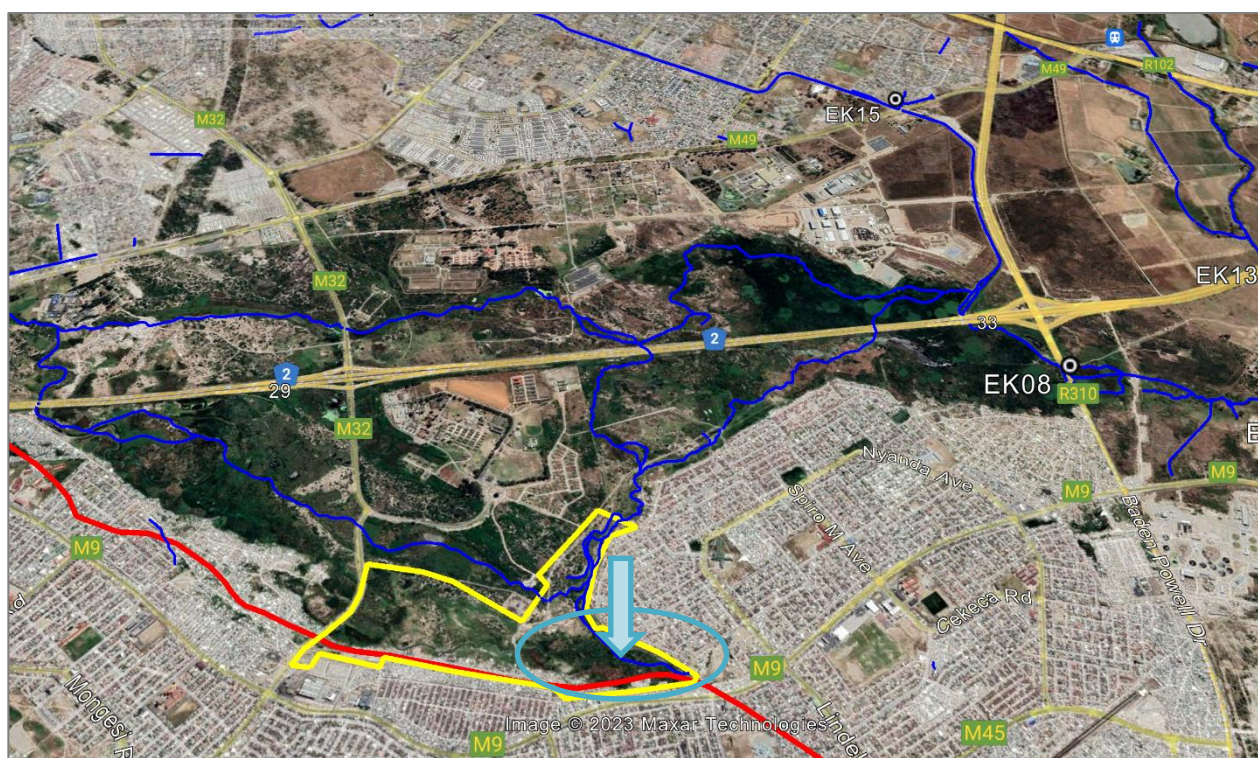
**Figure 6.9**

**Khayelitsha Canoe Club location (arrowed) in Khayelitsha Wetland Park (yellow polygon) showing the location of the nearest routine water quality monitoring point (EK08) on the main Kuils River channel downstream (Baden Powell Road).**

Without data, the fitness of this waterbody for intermediate contact recreational use cannot be commented on. It is however recommended that the CCT create an additional routine monitoring point within the Khayelitsha Wetland Park, in the reaches utilised by the canoe club, to provide some input into health risks imposed at different times by exposure to polluted waters.

At the same time, it is recommended that this section of the Kuils River subcatchment should be highlighted for specific interventions (e.g. stormwater diversion to sewer and aquatic alien plant clearing by the CCT), to support community-based initiatives such as the Khayelitsha Canoe Club.

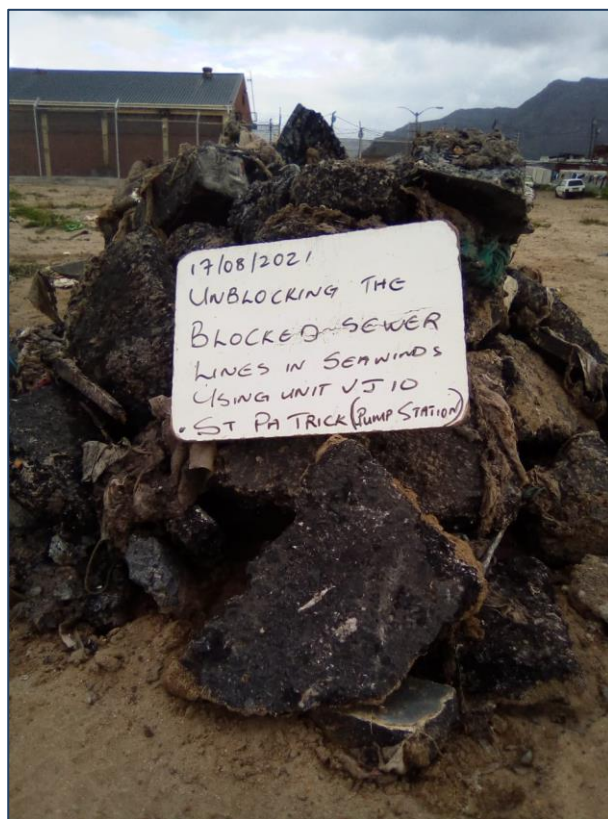
**Photo 7.1**  
**Rubble and other waste dumped in sewers**  
**contributes to blockages and overflows**  
**Photo courtesy CCT (Mr A. Taylor)**

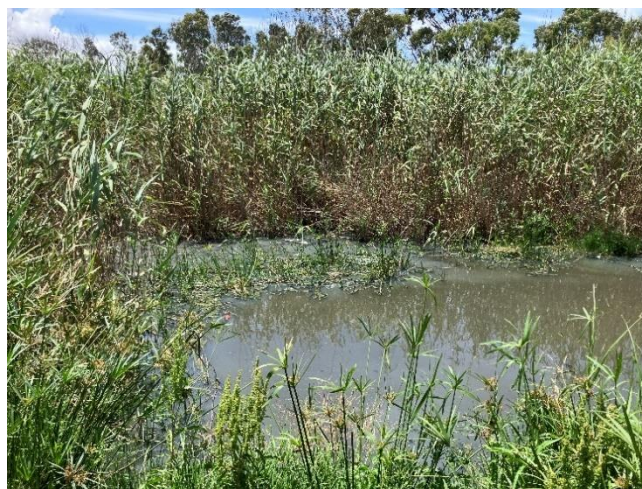
**Photo 8.2.2**  
Diep River at the railway crossing downstream of Dunoon – standing water only in summer 2022

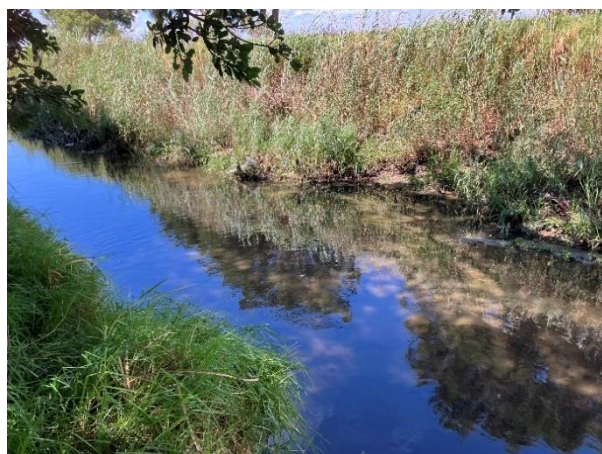
**Photo 8.2.3**  
Theo Marais channel upstream of WWTW inflows

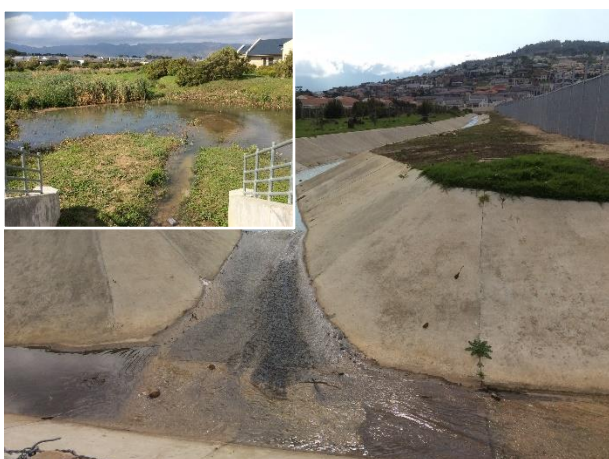
**Photo 8.3.1**

**Fast flows from a steep erosion-prone catchment bring sediment via the upper Soet, depositing it in stormwater ponds and channels (inset)**

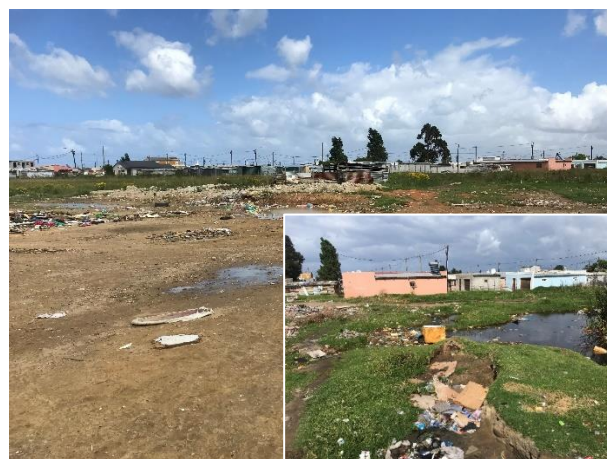
**Photo 8.3.2**

**Prior to its 2021 rehabilitation, the Asanda wetland was used as a dump site, and had visibly poor water quality**

- Rehabilitation of the Asanda wetland to incorporate it into a community wetland park: This is a LUW project. Project planning commenced in 2014, with detailed community stakeholder engagement. Actual project implementation commenced in 2021, and included removal of large volumes of solid waste and other fill from the wetland; installation of a pedestrian walkway across the wetland, where pedestrians previously had to walk through polluted water in winter; clearing of waste from, and repairs to, the catchpit at the outlet from the wetland into the downstream Soet River; construction of litter and sediment traps downstream of the N2; and the construction of a pathway as well as play and amenity areas along the wetland edge. Construction was nearing completion at the time of submission of this report, although management of dumping and removal of an illegal goat kraal were ongoing challenges;

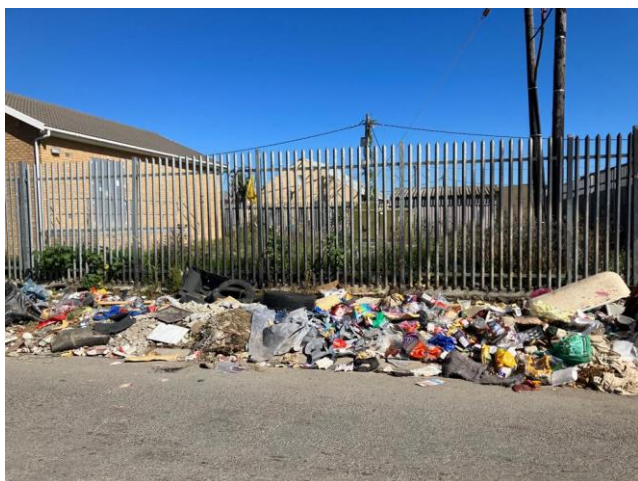
**Photo 8.3.3**  
**Solid waste in the Soet catchment**

- Removal of solid waste from the Soet River channel downstream of Asanda / Nomsamo – accumulation of solid waste is however an ongoing issue in this subcatchment.

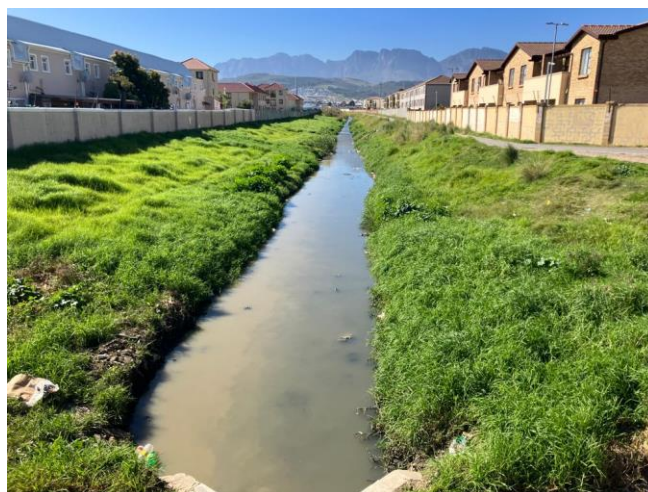
**Photo 8.3.4**  
**Soet River downstream of Asanda and Nomsamo**

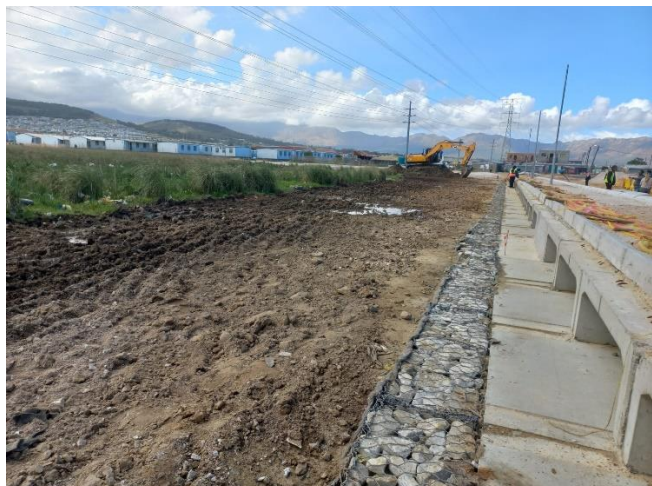
**Photo 8.3.5**

**Removal of fill and waste and the construction of a pedestrian causeway, play areas and footpaths at Asanda Wetland Park. Planning for this project commenced in 2014 and construction commenced in 2021 as part of the LUW programme**

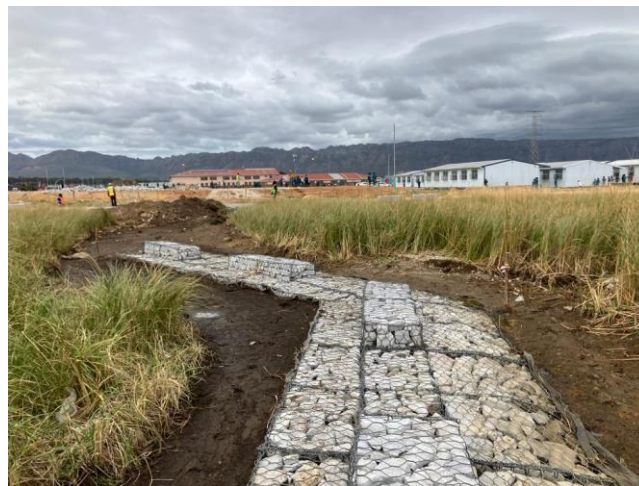
**Photo 8.3.6**

**Construction of a gabion weir across the Asanda wetland to spread stormwater inflows from upstream stormwater inflows. Earth and rubble fill as well as alien vegetation were removed at the same time**

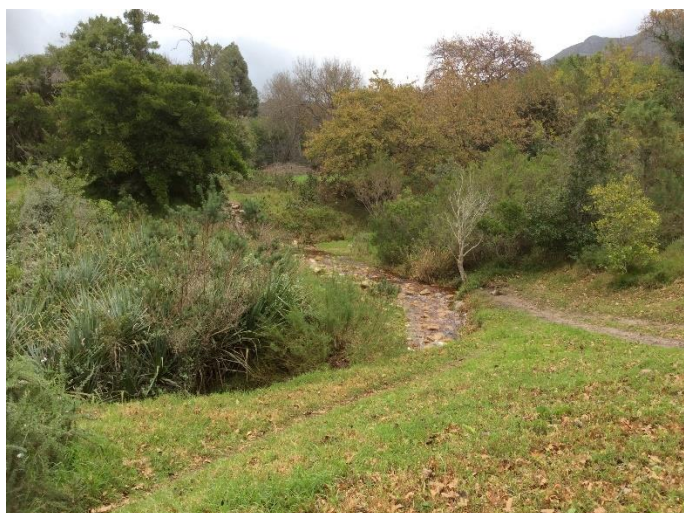
Photo 8.4.1

Eroding channel of the upper Liesbeek River, with still relatively unimpacted water quality

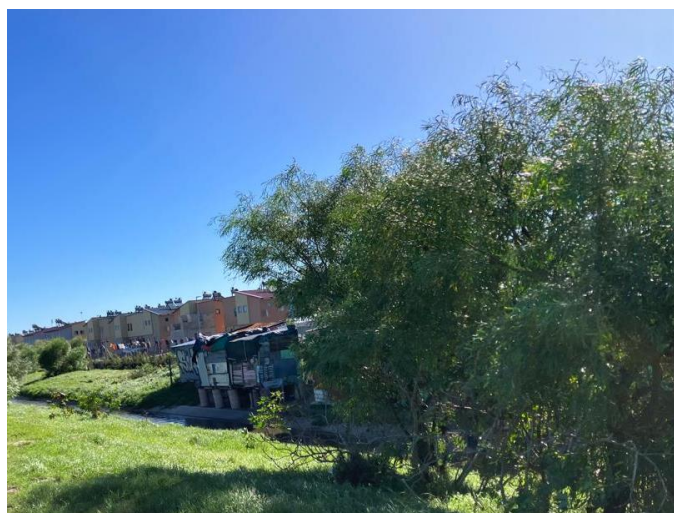
Photo 8.4.2

Informal housing built right over the edge of the Jakkalsvlei Canal, along the N2 past Langa

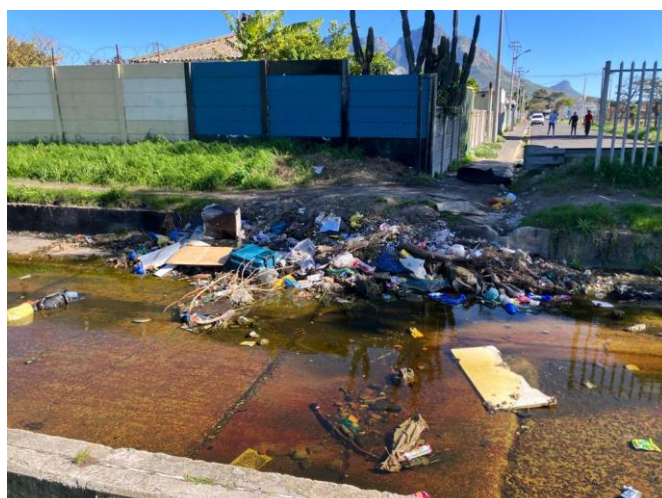
Photo 8.4.4

Kromboom Canal just upstream of the Black River confluence near the N2. Access to the canal off side streets allows dumping into the canal
