## **CITY OF CAPE TOWN INLAND WATER QUALITY REPORT FOR THE PERIOD APRIL 2020 TO MARCH 2022 (2020 AND 2021 REPORTING PERIODS)**

**FINAL**

MAY 2023

### **TECHNICAL REPORT**

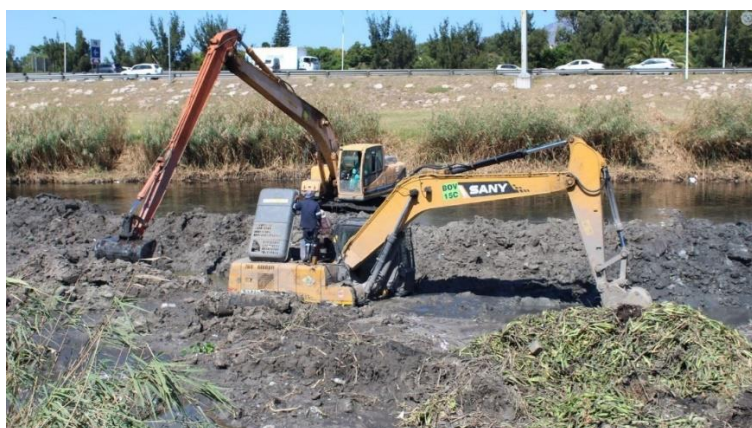
Photo 8.4.5

Dredging organic sludges and solid waste from the Black River  
Photo courtesy CCT<sup>12</sup>

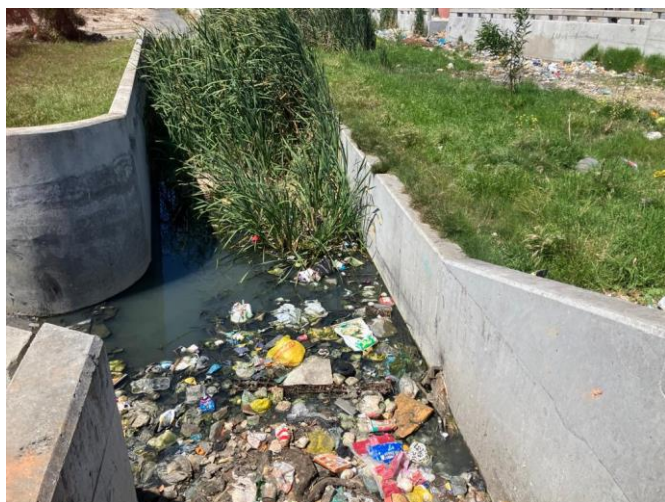
Photo 8.5.1

Out of sight, out of mind – blocked stormwater pipe to Kuils River, Bardale

These unserviced areas, and high levels of crime and poor access into burgeoning informal and backyard developments, also result in at-times prolonged sewage overflows and other point-source inflows into the stormwater system and from there, directly, or indirectly into wetlands and rivers (see **Photos 8.5.1** and **8.5.2**).

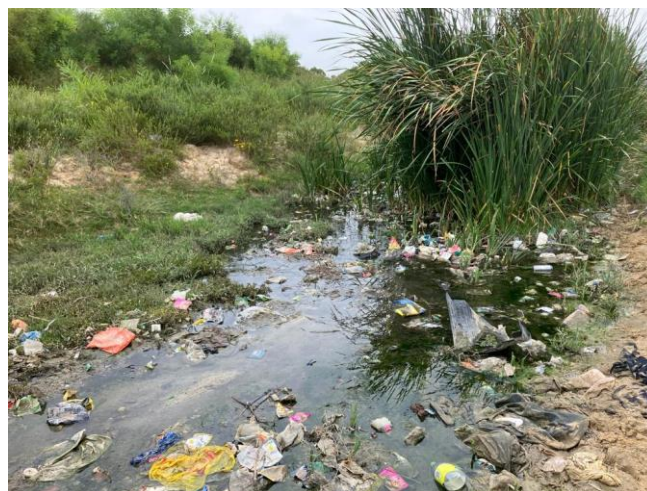
Photo 8.5.2

Dry weather (Dec 2022) flows in Mfuleni suggest pollution sources

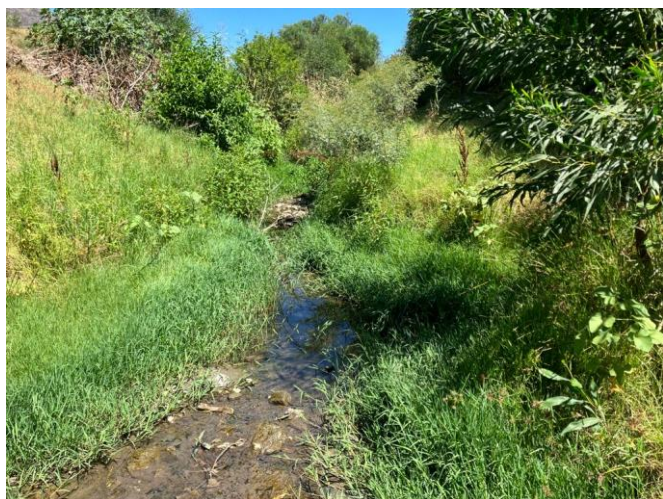
Photo 8.6.1

**Example of the transformed lower reaches of the Hout Bay River, significantly affected by encroachment of invasive alien vegetation along the channel banks**

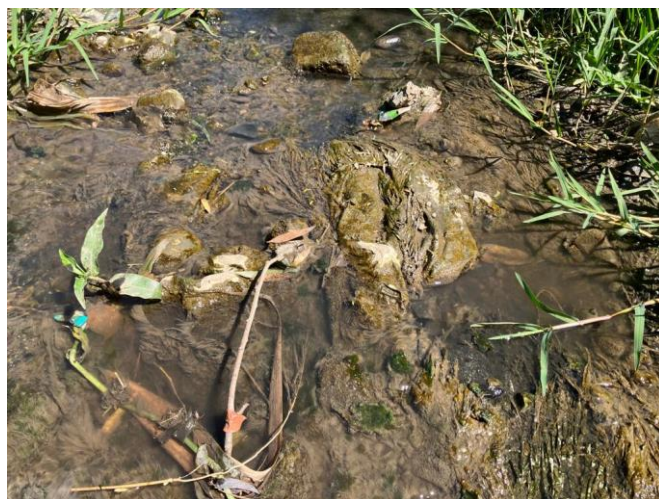
Photo 8.6.2

**Close-up shot showing the visibly polluted lower reaches of the Hout Bay River, where there is a proliferation of algal growth and instream alien vegetation**

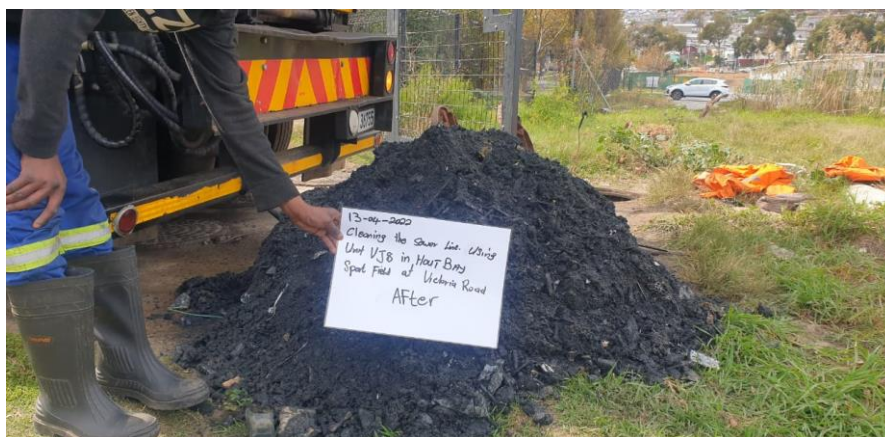
**Photo 8.6.3**

**Debris cleared from sewer pipes in the Hout Bay catchment (April 2022)**  
[photo credit: Andrew Taylor, City of Cape Town]

Subsequent to the reporting period considered in the current report, the CCT has however undertaken sewer pipe cleaning work along the Hout Bay River (April – July 2022), to prevent the blocking and surcharging of sewer pipes (**E.G.** see **Photo 8.5.3**).

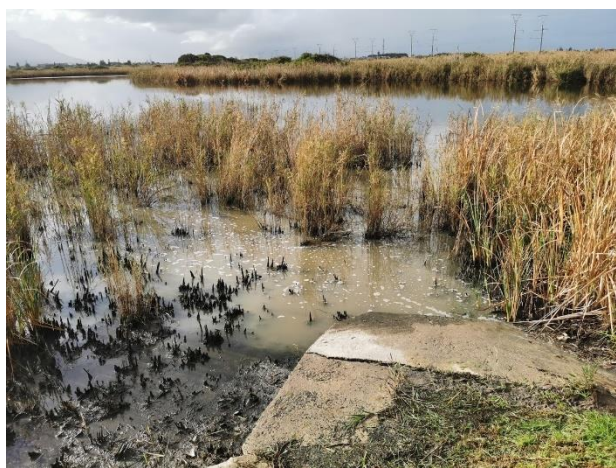
**Photo 8.7.1**  
Sewage spilling into Zandvlei [photo credit: Kyron Wright, City of Cape Town]

Nutrient inputs from agricultural, industrial and residential areas are a problem for Zandvlei, as are inputs of oil, heavy metals and other toxicants from the increasingly urbanised catchment. Sewage spills, however, remain the most significant contributor to poor water quality in the vlei, with a number of significant closures to recreational use since 2018 (pers. comm., Kyron Wright, CCT; Kotze, 2020; Human, 2021). The longest closure to date was May 2021- February 2022. Sewage spills contribute to nutrient enrichment of the vlei, exacerbating the incidence of algal blooms and the prolific growth of problem plants in the vlei. Sedimentation of Zandvlei from forestry and agricultural land-uses in the upper catchment areas is also a major problem, having resulted in a decrease in the depth of the vlei by approximately 0.5 m (pers. comm., Kyron Wright, CCT) and probably being a significant source of particle-bound phosphorus into the system, thus contributing to the nutrient enrichment.

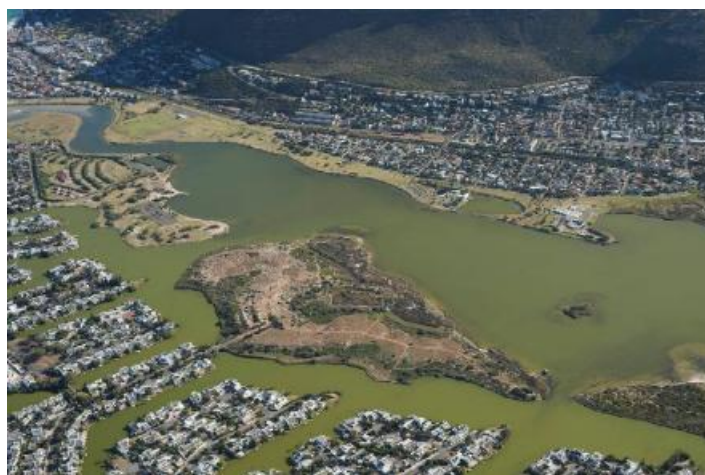
**Photo 8.7.2**  
Aerial photograph showing an algal bloom in Zandvlei [photo credit: Kyron Wright, City of Cape Town]

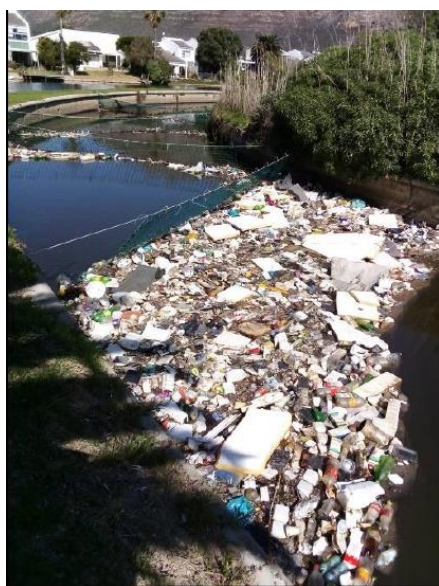
**Photo 8.7.3**

**Litter trapped in nets for removal from one of the canals in the Sand catchment that flows into Zandvlei [photo credit: Kyran Wright, City of Cape Town]**

- Cured-in-Place Pipe (CIPP) lining of leaking and/or old sewer pipes at a number of locations in the catchment;
- Cleaning out of sewer pipes in the Lavender Hill and Overcome Heights areas (May – November 2021) (pers. Comm., Andrew Taylor, CCT);
- Repair of damaged sewage infrastructure as soon as possible when incidents occurred, and investment by the Water and Sanitation Department in measures to prevent the high volumes of dumped materials (rags, rubble, etc.) from entering the pump stations, which is one of the leading causes of failure and spillage (CCT, 2021);
- Extensive engagement with the Zandvlei Protected Advisory Action Committee through the City's Stormwater and Biodiversity Management branches (CCT, 2021);
- Collection and clearing of litter from the waterways that flow into Zandvlei (e.g. see **Photo 8.7.3**).

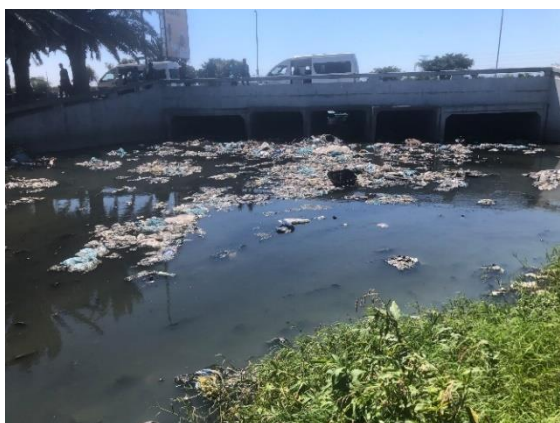
Photo 8.8.1

Litter in the Big Lotus River near Hanover Park

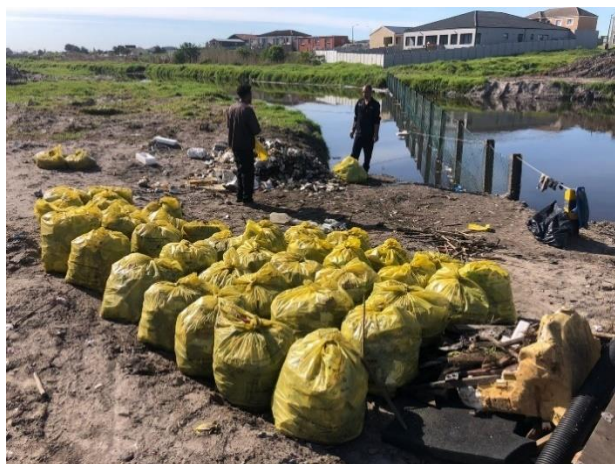
**Photo 8.8.3**

**CCT staff clearing solid waste from the new litter fence installed on the Big Lotus River in 2022**

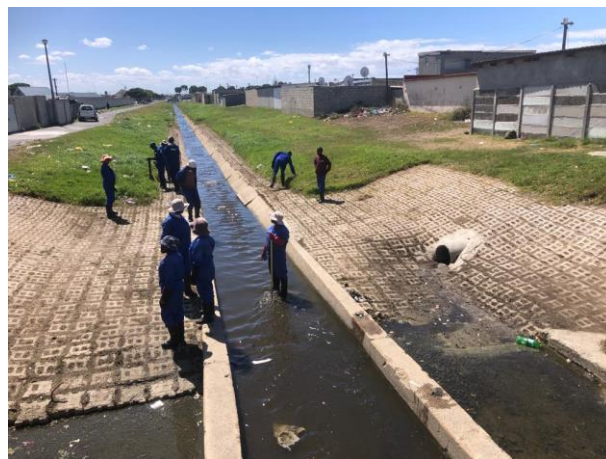
**Photo 8.8.4**

**CCT work teams clearing solid waste from the Big Lotus River**
